Implementation Monitoring of Forestry Best Management Practices for Harvesting And Site Preparation in South Carolina, 2001-2003

Darryl Jones
Environmental Management Coordinator
South Carolina Forestry Commission

**Best Management Practices
Monitoring Report BMP-5**

Published by the South Carolina Forestry Commission
Columbia, South Carolina
January 2005

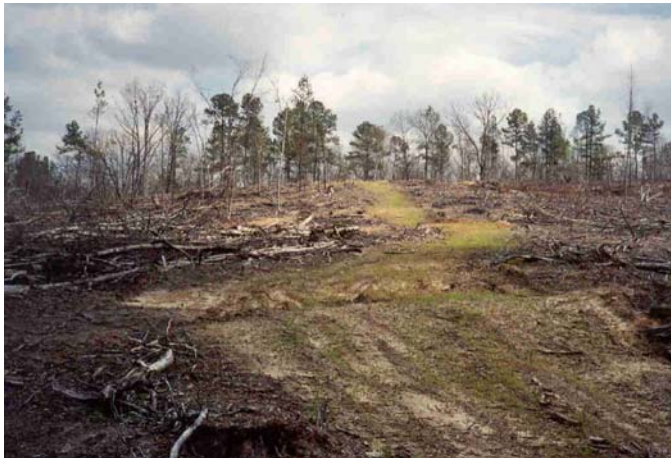
Figure 2: Haul road stabilized with vegetative cover.

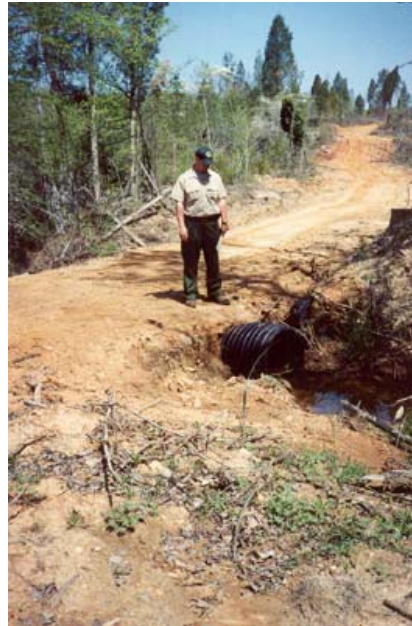
In this survey, 18 of the 200 sites surveyed for compliance with BMPs related to timber harvesting involved the construction of haul road stream crossings. Of these 18 stream crossings, 14 were designed, constructed, and maintained in compliance with BMPs. Four of the 18 sites were rated as unacceptable. Deficiencies noted with the stream crossings on the unacceptable sites included insufficiently sized culverts, lack of stabilization at the stream crossing, and poor stabilization on the approaches to the road stream crossing. Compliance with BMPs related to haul road stream crossings was somewhat lower in this survey than in the previous survey, where compliance was 86.7% (Jones, 2000).

Figure 3: Poorly installed culvert on a haul road.

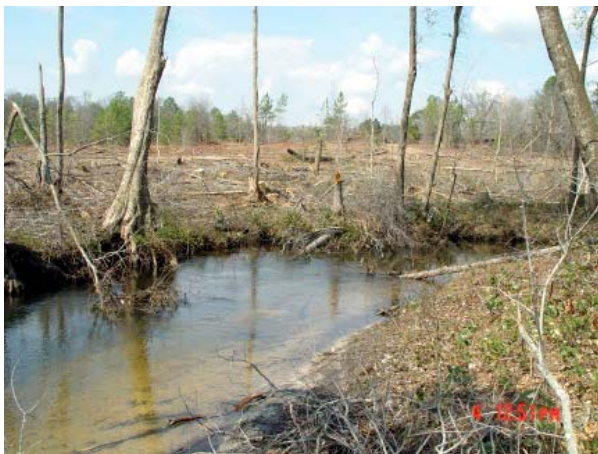
Figure 4: The SMZ was harvested adjacent to this perennial stream.

completely harvested (10 sites), when insufficient overstory basal area was retained within the SMZ (5 sites), woody debris was left in the stream (4 sites), and when log decks or excessive vehicle traffic resulted in excessive bare mineral soil exposure within the primary SMZ (3 sites). Compliance with BMPs related to the streamside management zone was higher in this survey (87.3%) compared to 83.7% in the last survey (Jones, 2000).

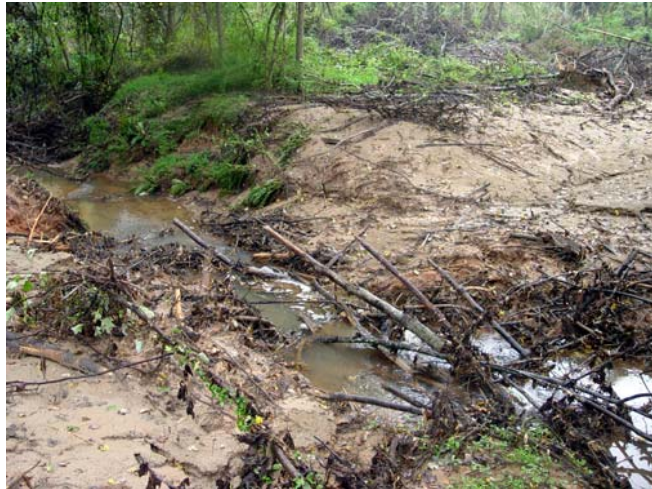
Figure 5: Poorly designed skid trail crossing left in place.

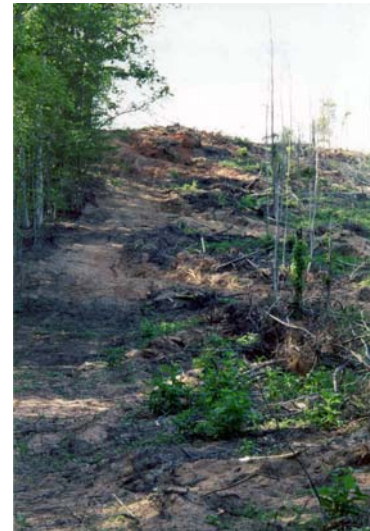
Figure 7: Bladed fireline with water bars installed.
